BIELA14 Series

Gen II LOV™ Electric Fryer

Service Manual

Part Number: FRY_SM_8196446 02/2016

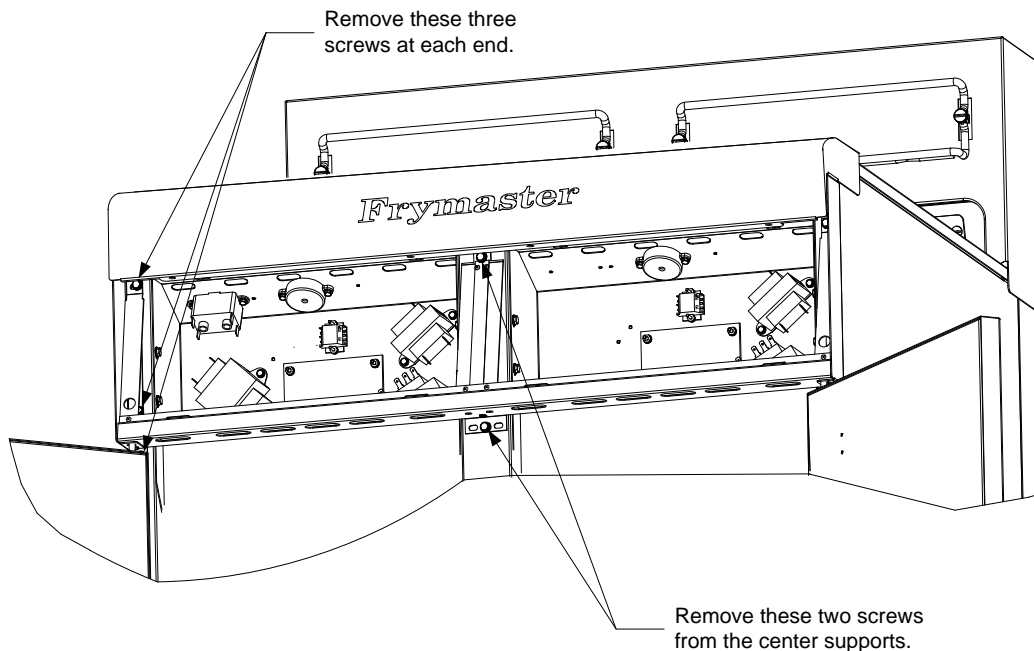
NOTE: If more room to work is required, the control panel frame assembly may be removed by removing the hex-head screws which secure it to the fryer cabinet (see illustration below). If this option is chosen, all computer assemblies must be removed per steps 1 thru 4 above. The cover plate, on the lower front of the component box, may also be removed to allow additional access if desired.

Removing the Control Panel Frame and Top Cap Assembly

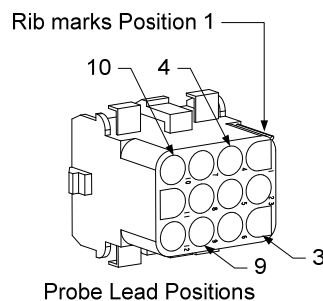
9. Insert the temperature probe leads into the 12-pin connector C-6 (see illustration below). For full-vat units or the right half of a dual-vat unit (as viewed from the rear of the fryer) the red (or yellow) lead goes into position 3 and the white lead into position 4 of the connector. For the left half of a dual-vat unit (as viewed from the rear of the fryer), the red (or yellow) lead goes into position 9 and the white lead into position 10. **NOTE: Right and left** refer to the fryer as viewed from the rear.

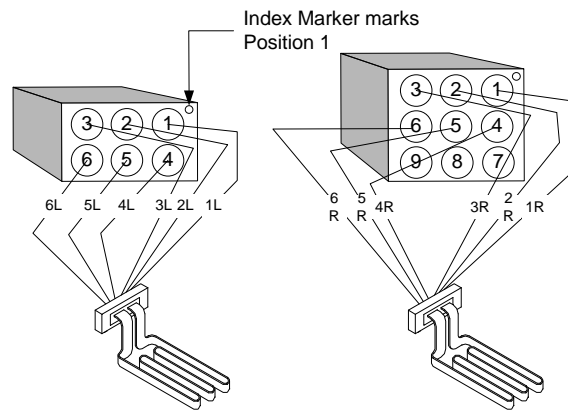
Full vat element wire routing

Pull the element wires through the bushings on either side of the frypot and down the back. Element wires should be routed to the right of the ATO temperature probe on the back wall of the frypot.

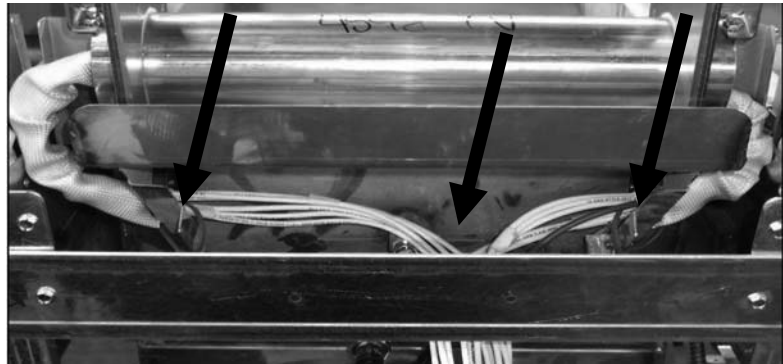
Dual vat element wire routing

Pull the element wires through the bushings on either side of the frypot and down the back. Element wires should be routed to the center of the frypot between the ATO temperature probes.

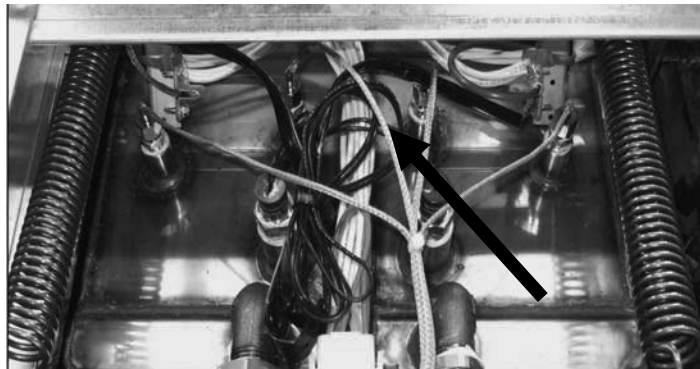
Element grounding and wire routing

To ground the element wires, use the hole in the frypot frame located under the bushing that the element wires pass through. Using a screw through the ground wires ring terminal, connect it to the frypot using the probe ground clip. Use a tie wrap to tie up half of the element wires after the wires are pulled through the bushing. Do not pull tie wrap tight, leave it slack at about one inch

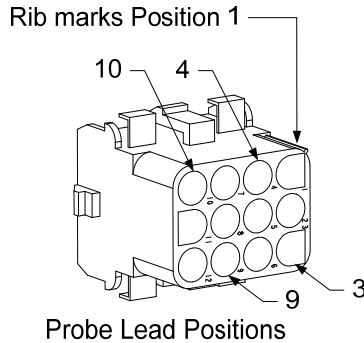
8. Reconnect the element connector ensuring that the latches lock.
9. Insert the temperature probe leads into the 12-pin wiring harness connector (see illustration below). For full-vat units or the right half of a dual-vat unit, the red lead goes into position 3 and the white into position 4. For the left half of a dual-vat unit, the red lead goes into position 9 and the white into position 10. **NOTE: *Right* and *left*** refer to the fryer as viewed from the rear.

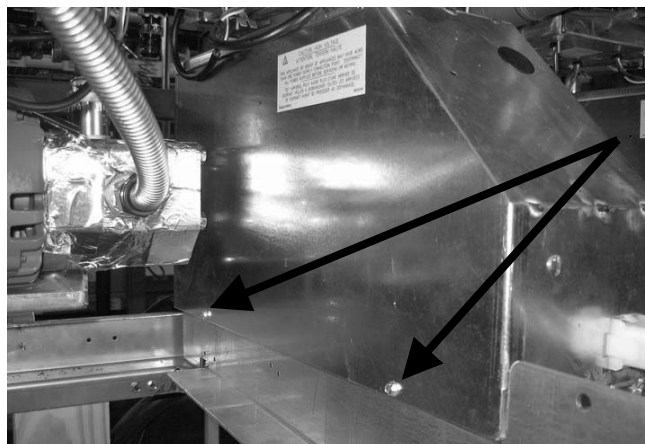
Remove two screws to access contactor box components above the filter pan.

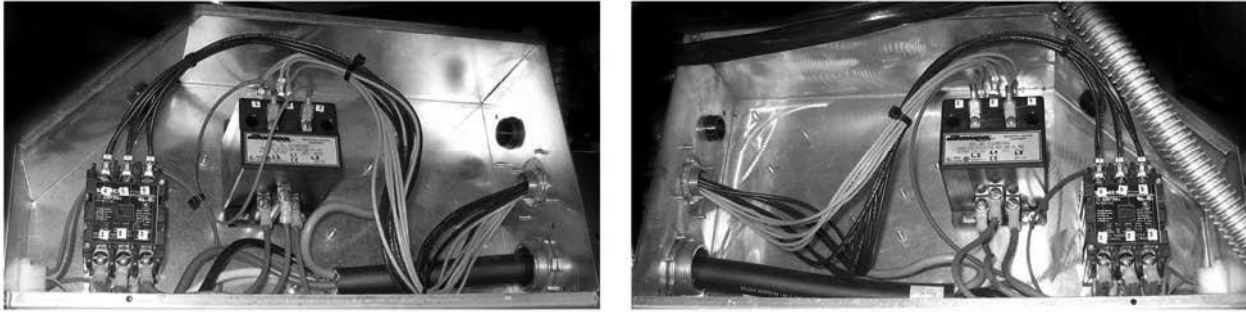
4. The contactors and relays are held on by threaded pin studs so that only removal of the nut is required to replace the component.
5. After performing necessary service, reverse steps 1-4 to return the fryer to operation.

Left and right views of mechanical contactor box components.

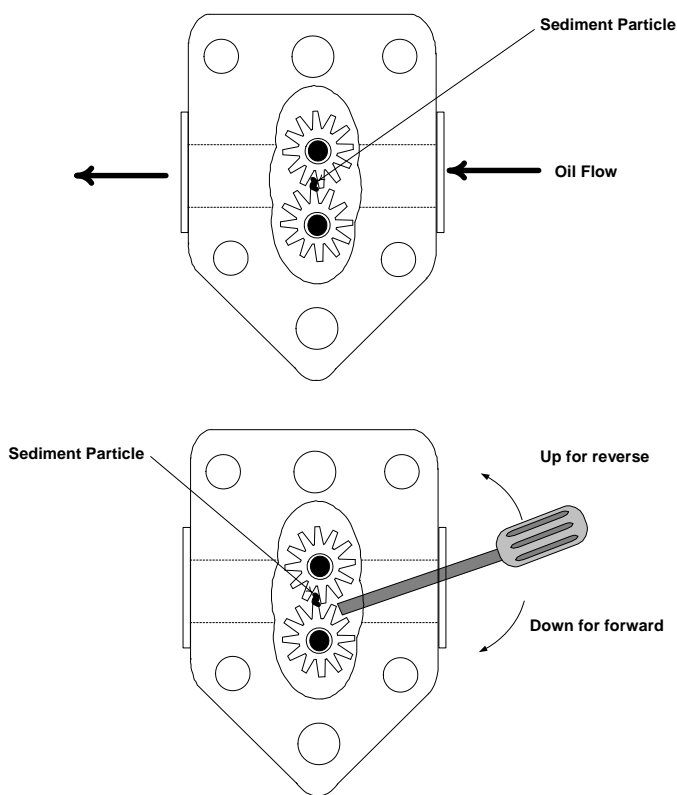
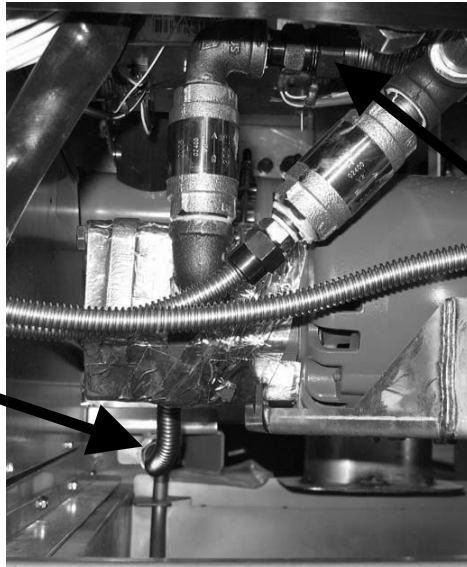
2. Disconnect the fryer from the electrical power supply and reposition it to gain access to both the front and rear.
3. Disconnect the flexline running to the oil-return manifold at the rear of the fryer as well as the pump suction flexline at the end of the filter pan connection (see photo on the following page).

Disconnect flexlines indicated by the arrows.

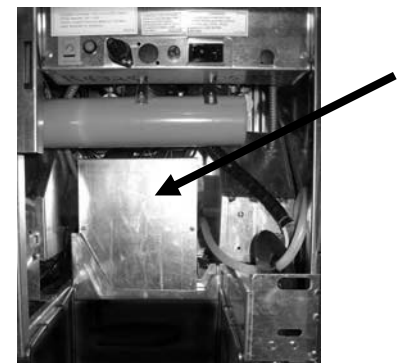
The ATO board is located inside the box, behind the JIB (see Figure 1). The power for the ATO board is supplied from the right hand component box. The power passes through the transformer inside the ATO box to the board.

Disconnect the fryer from the electrical power supply. Locate the ATO box (see Figure 1 on page 12), behind the JIB (Jug In Box). Remove the cover to expose the transformers, relay and LON gateway (if installed) (see Figure 2). Mark and unplug any wires or harnesses. Once the LON gateway is removed the ATO board is visible (see Figure 3). Replace the defective component and reattach all wires or harnesses. Replace the cover. Once replaced, **CYCLE POWER TO ENTIRE FRYER SYSTEM**. See section 1.11.7 on page 1-22 to reset control power. Check software version and if necessary update the software. If a software update was necessary, follow the instructions to update the software in section 1.15

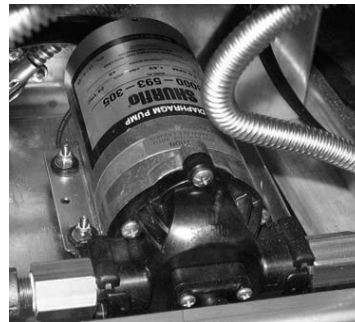
Figure 4

Disconnect the fryer from the electrical power supply. Locate the ATO pump (see Figure 4), behind the ATO box. Mark and unplug any wires or harnesses. Press up from the bottom on the quick disconnects to release the plumbing (see Figure 5). The plumbing can be pulled from the pump. Loosen the four nuts attaching the pump to the pump tray. Replace the defective component and reverse above steps. Once replaced, reconnect the power.

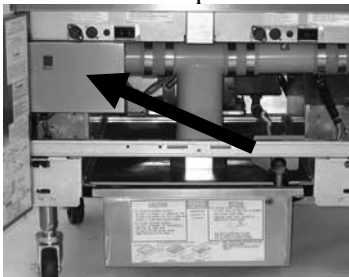
The MIB controller is located inside the left cabinet (see Figure 6). In normal operation a cover hides the MIB controls and only the LED display is visible. The cover is held in place with three torx screws. In normal operation, an “A” is displayed for automatic mode. The MIB control board is useful for diagnostic purposes. It allows manual operation of both the actuators and filter pump without using the M3000 computer.

Figure 6: MIB controller cover.

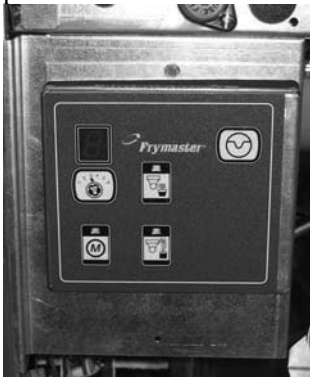
Figure 11

Disconnect the fryer from the electrical power supply. Remove the torx screws from the MIB cover, exposing the MIB board (see Figure 11). Removing the screw at top center lets the MIB board hinge down. Carefully remove the plugs on the rear of the board (see Figure 12). Replace with a new MIB board and reverse steps to reassemble. Once replaced, **CYCLE POWER TO ENTIRE FRYER SYSTEM**. See next section to reset control power. Check software version # and if necessary update the software. If a software update was necessary, follow the instructions to update the software on in section 1.15 ensuring the MIB reset button is pressed and held for five seconds at the end of the update to update the MIB.

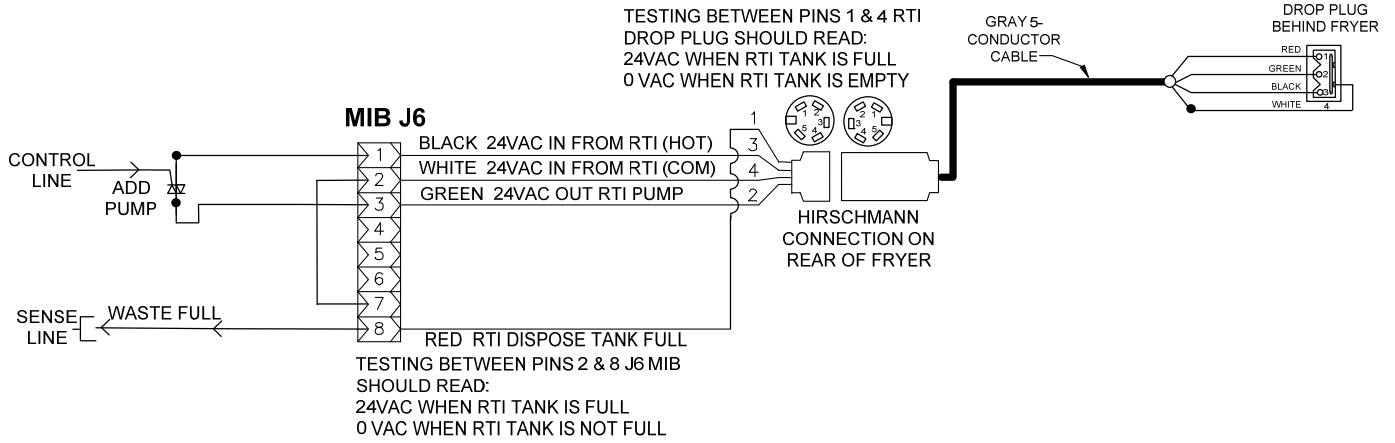
BULK OIL LOV WIRING

1.12.2 RTI LOV™ Wiring

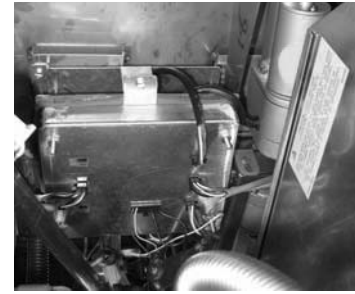
Figure 13

The AIF (Automatic Intermittent Filtration) board controls the actuators that open and close the drain and return valve. The AIF boards are located inside a protective housing under each frypot (see Figure 13).

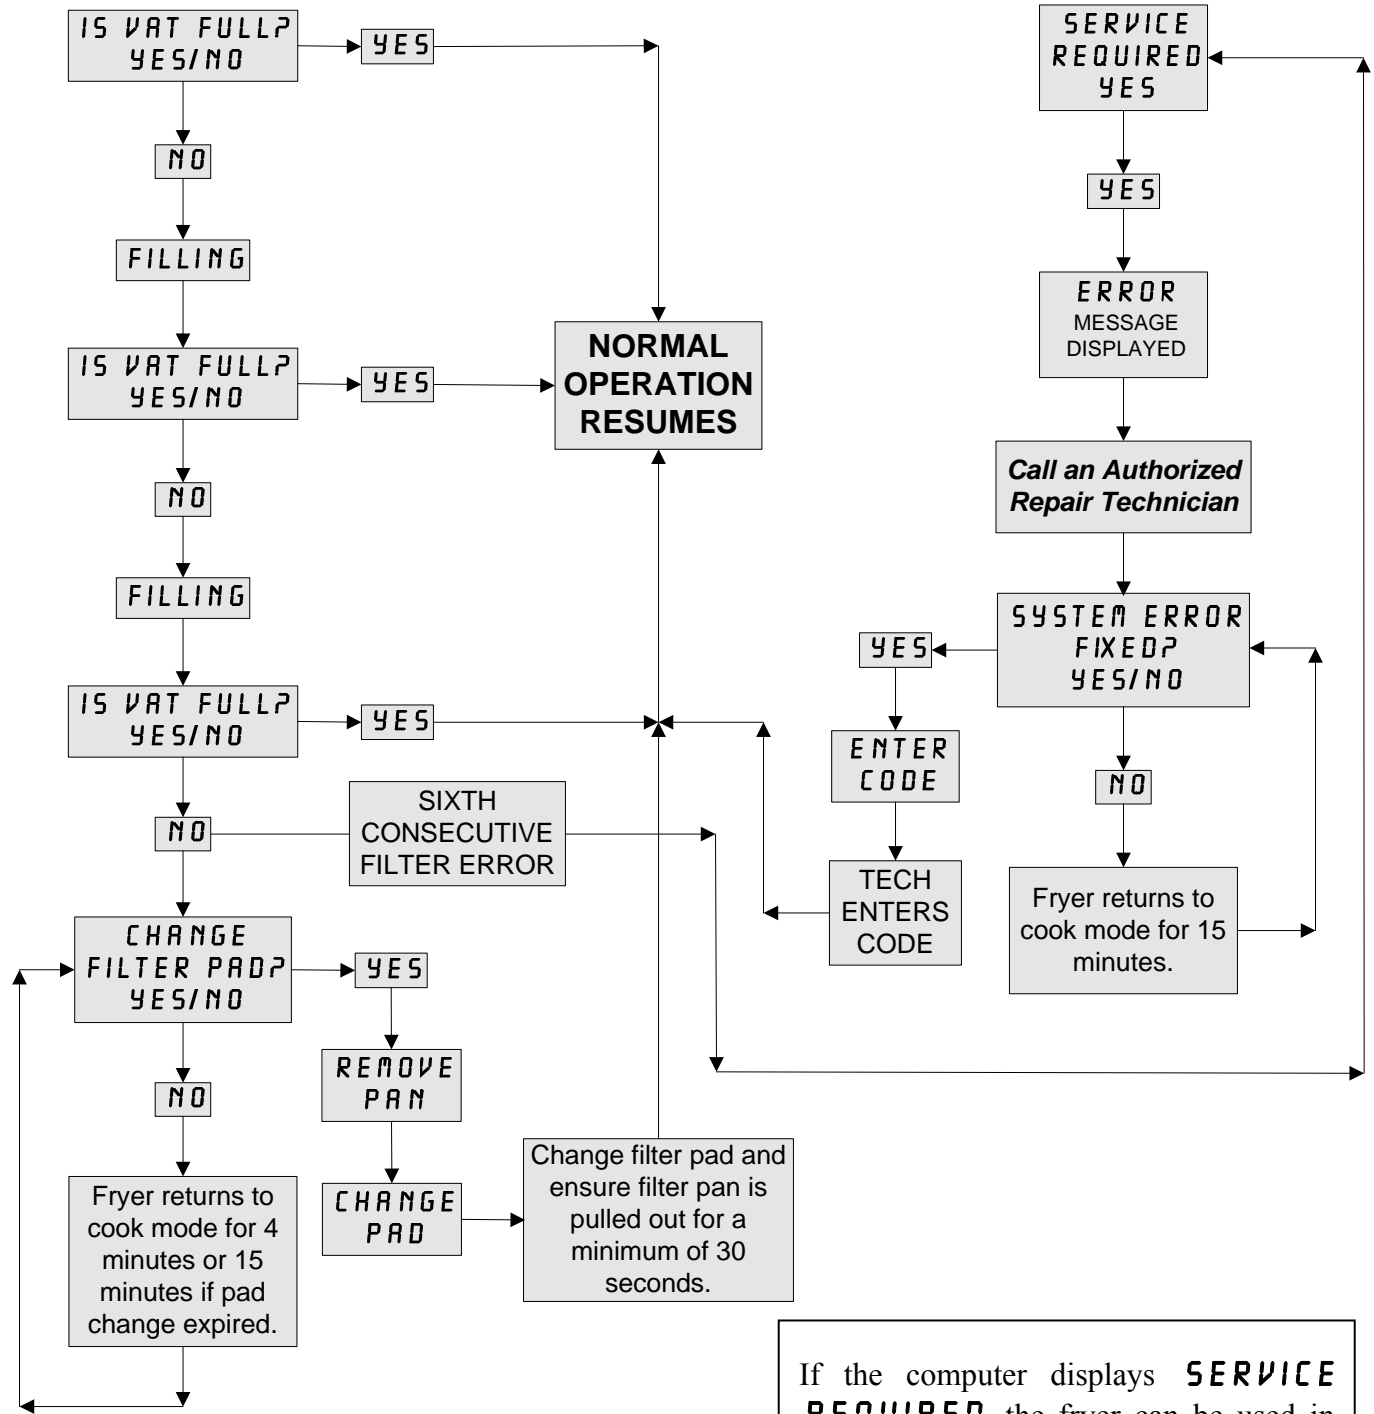
1.14.6 M3000 Filter Error Flowchart

This chart follows the process of clearing a filtration issue. The prompt is displayed when any of the following occur:

1. a clogged filter pad,
2. a tripped or defective filter pump,
3. a leaky O-ring on the pick-up tube,
4. a failed drain valve/actuator, or
5. a failed return valve/actuator.

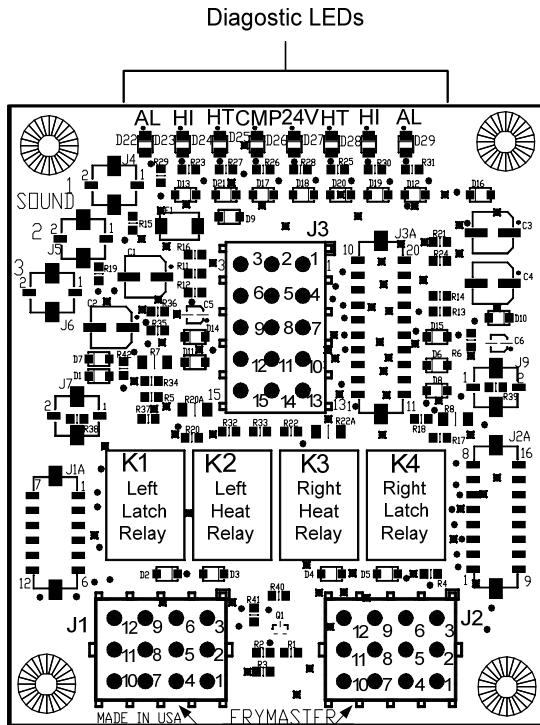
1.17 Interface Board Diagnostic Chart

The following diagram and charts provide ten quick system checks that can be performed using only a multimeter.
