BIGLA30-T Series

Gen III LOV™ Gas Fryer

Service Manual

Part Number: FRY_SM_8197205 03/2016

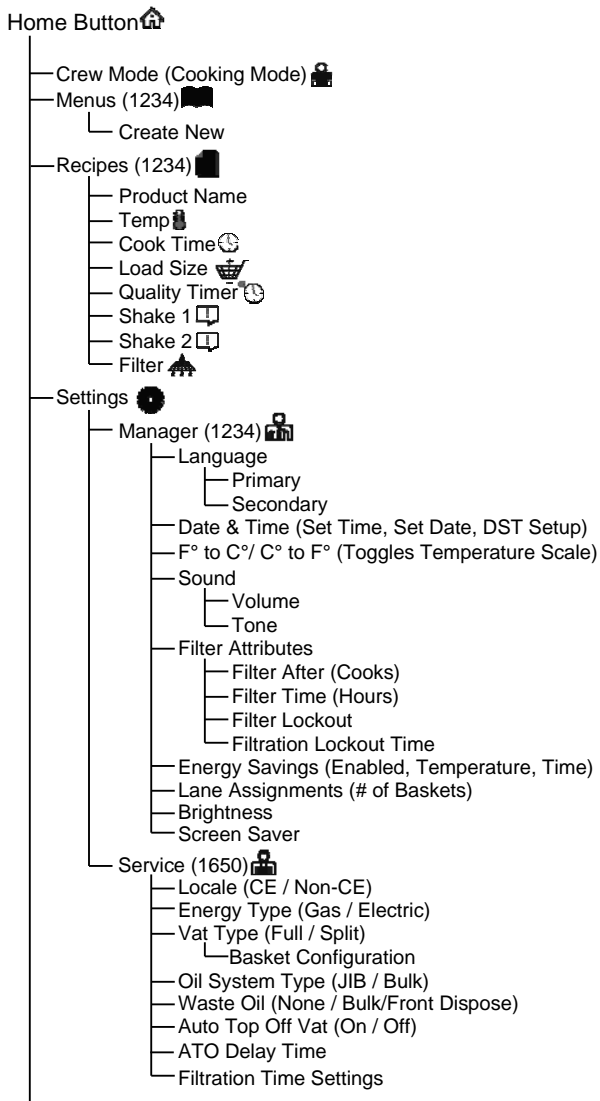
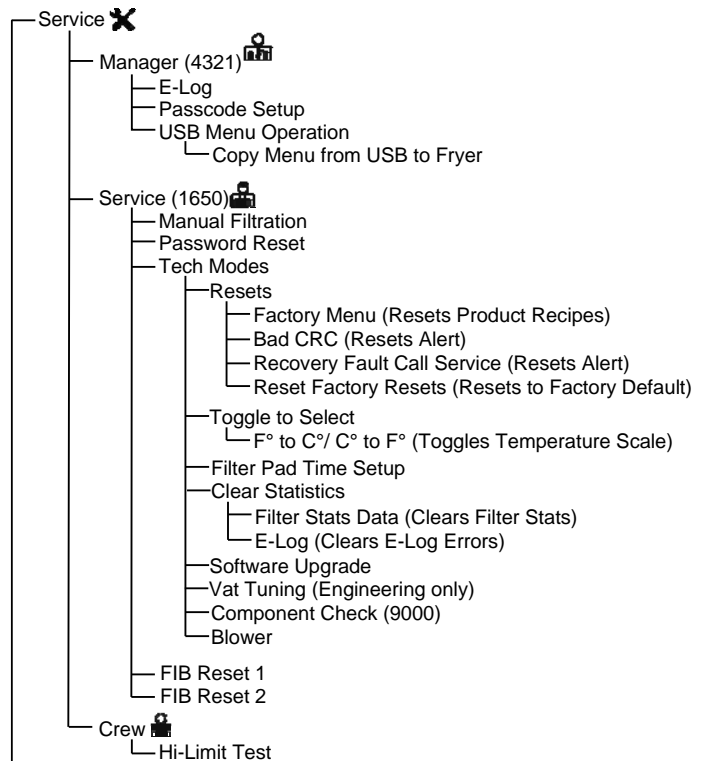
Reflected below are the major programming sections in the M4000 and the order in which the headings will be found in the controller.

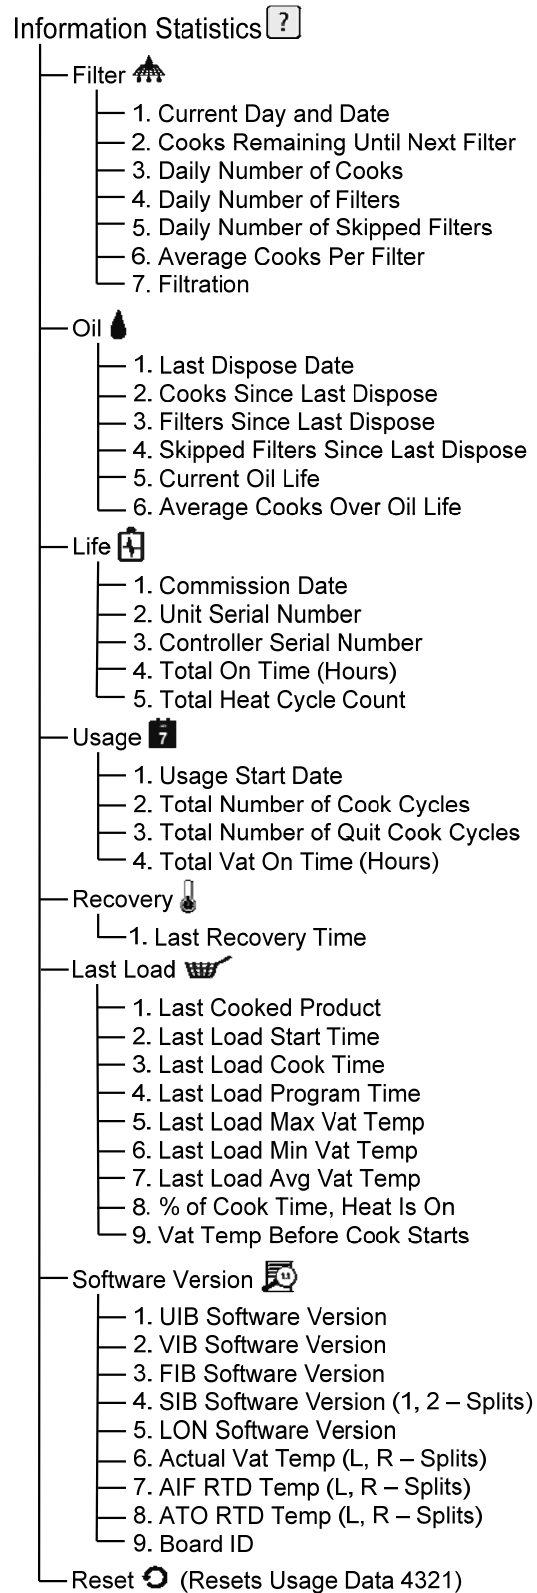
1.1.2 M4000 Information Statistics Menu Tree

Reflected below are the information statistics in the M4000 and the order in which the headings will be found in the controller.

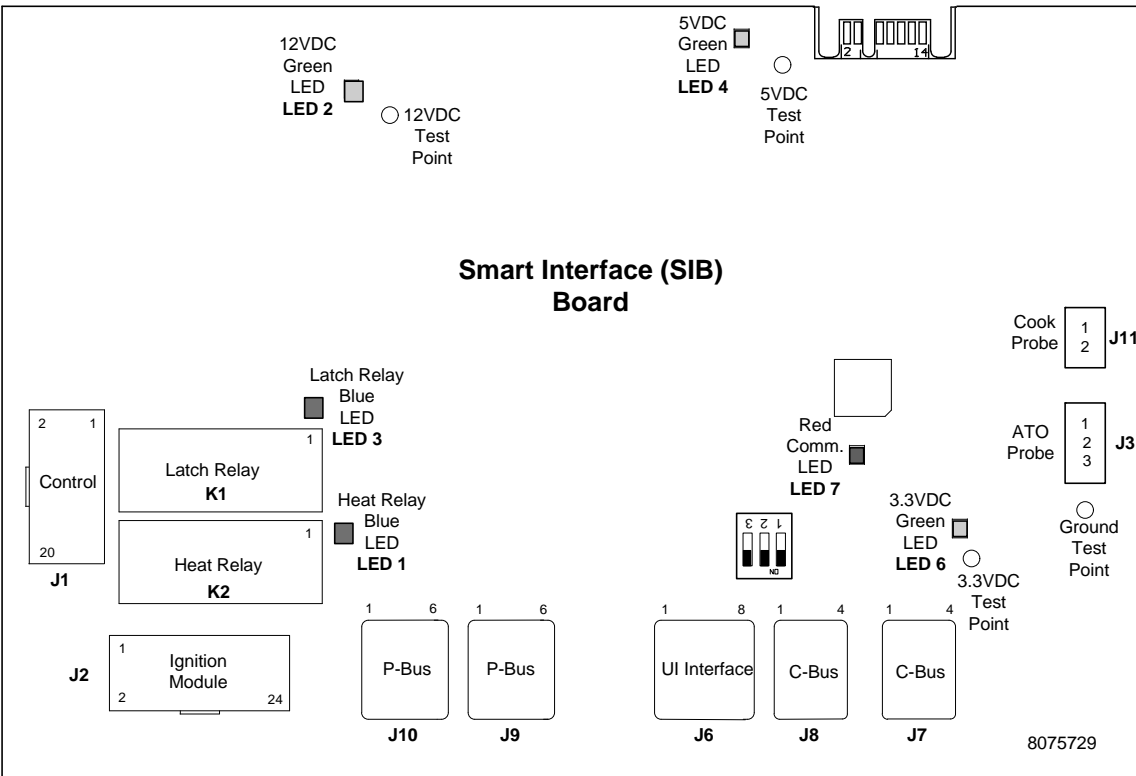
All fryers in this series have a smart interface board (SIB) located in the component box behind the controller panel. The SIB board provides a link between the controller and the fryer's individual components without requiring excessive wiring, and executes commands from one central point.

K2 is a single-pole-double throw (SPDT) relay that supplies 24VAC to the ignition and gas valve circuits. The relays on this board are soldered to the board. If a relay fails, the board must be replaced. K1 is a single-pole-double throw (SPDT) relay that supplies voltage through the high limit and the optional air pressure switch.

LEDs (labeled LED1 through LED7) are arrayed around the board to assist in troubleshooting.

The charts on pages 1-8 and 1-9 illustrate current flow through the board, and the table at the top of page 1-10 identifies frequently used test points.

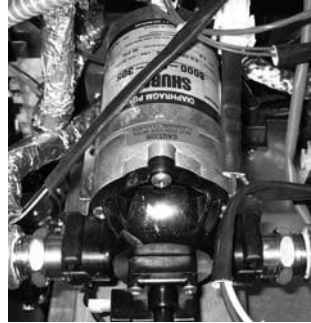
Figure 33

Disconnect the fryer from the electrical power supply. Locate the ATO pump (see Figure 33), behind the ATO box. Mark and unplug any wires or harnesses. Press down from the top on the quick disconnects to release the plumbing (see Figure 34). The plumbing can be pulled from the pump. Loosen the four nuts attaching the pump to the pump tray. Disconnect the electrical connection. Replace the defective component and reverse above steps. Once replaced, reconnect the power.

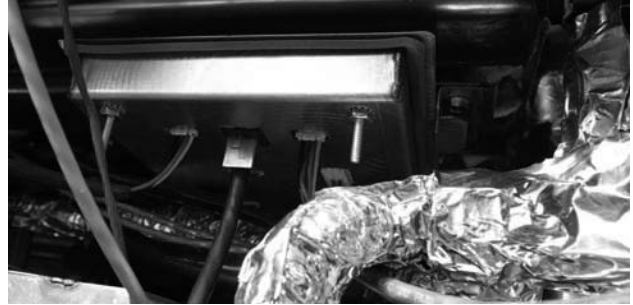
Figure 39

The VIB (Valve Interface Board) controls the actuators that open and close the drain and return valves. The VIB boards are located inside a protective housing under each frypot (see Figure 39).
