BIGLA30 Series

LOV™ Gas Fryer

Service Manual

Part Number: FRY_SM_8196316 05/2015

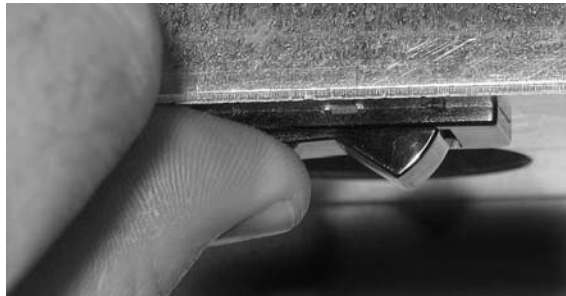
Figure 14

The control power reset switch, is a momentary rocker switch located below the left control box (see Figures 14), that resets all power to all the computers and boards in the fryer. It is necessary to reset all power after replacing any computer or board. Press and hold the switch for at least ten seconds when resetting the control power to ensure power has sufficiently drained from boards.
