FilterQuick[™] FQG30 Gas Fryer

Service Manual

Part Number: FRY_SM_8197109 12/2016

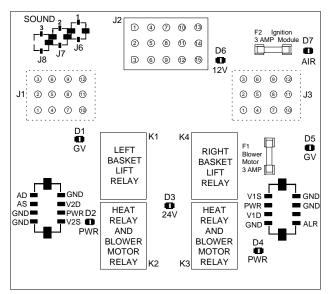
LEDs (labeled D1 through D7) are arrayed around the board to assist in troubleshooting.

INTERFACE BOARD LED DIAGNOSTIC LIGHTS								
D1	24 VAC to left gas valve (dual vat only)								
D2	24 VAC to left ignition module								
D3	24 VAC from transformer								
D4	24 VAC to right ignition module								
D5	24 VAC to gas valve (right valve if dual vat)								
D6	12 VAC from transformer								
D7	CE and Japanese units only: air switch closed

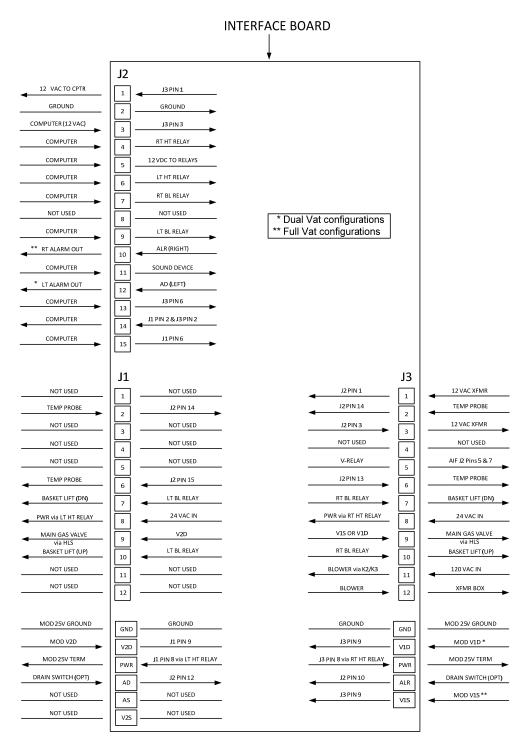
CURRENT FLOW THROUGH INTERFACE BOARD 106-6706 (SMT HE SERIES APPLICATION)

The chart on the following page illustrates current flow through the board, and the table at the top of page 1-4 identifies frequently used test points.

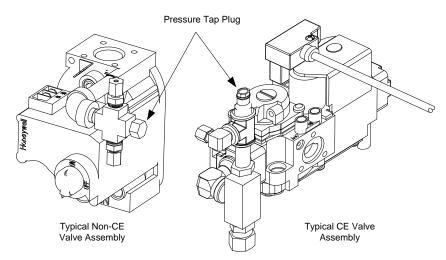
2. Remove the pressure tap plug from the gas valve assembly.

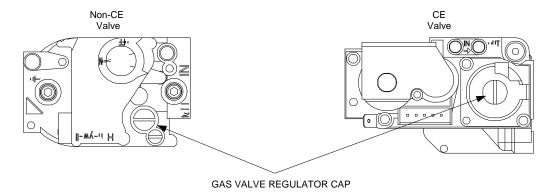
6. To adjust the burner gas pressure, remove the cap from the gas valve regulator and adjust to the correct pressure.

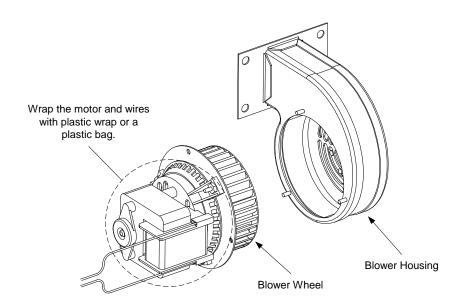
The air pressure switch on the combustion blower should read: Full Vat units-122pa (0.5 inches W.C.) and for Split Vat units-180pa (0.72 inches W.C.).

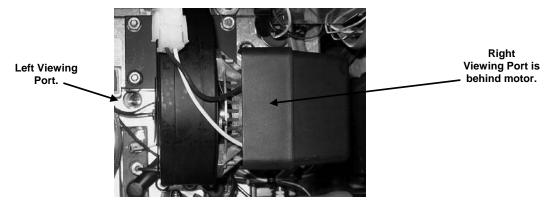
The air/gas mixture is properly adjusted when the burner manifold pressure is in accordance with the applicable table on page 1-5 and the burners display a bright orange-red glow. If a blue flame is observed or if there are dark spots on a burner face, the air/gas mixture requires adjustment.

NOTE: Opening the air shutter too much may result in whistling. It should not be more than 1/3 open.

On the side of the blower housing opposite the motor is a shutter plate with a locking nut. Loosen the nut enough to allow the shutter to be moved, then adjust the position of the shutter to open or close the air intake opening until a bright orange-red glow is obtained, then close it slightly. Carefully hold the shutter in position and tighten the locking nut (see illustration on the following page).

On non-CE blowers loosen this nut and rotate shutter to open or close air intake.

On CE blowers loosen both wing nuts and slide the shutter to adjust the air intake.

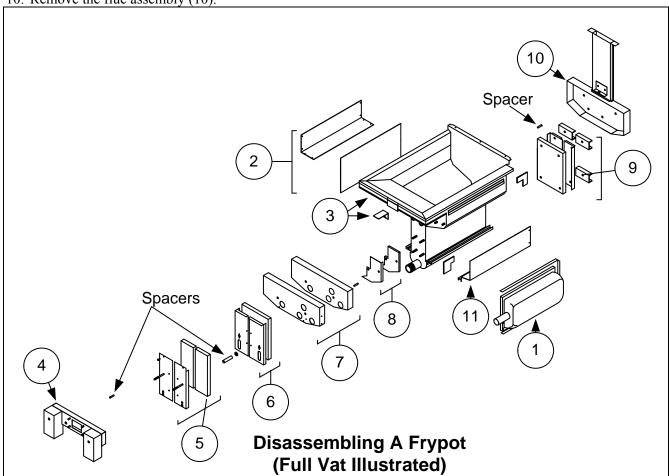
- 9. Remove the rear lower combustion chamber retainers, back, and insulation (9). **NOTE:** Full-vat units have two-piece backs and four retainers. Dual-vat units have one-piece backs and two retainers.

- 10. Remove the flue assembly (10).

See page 1-16 for reassembly illustration.

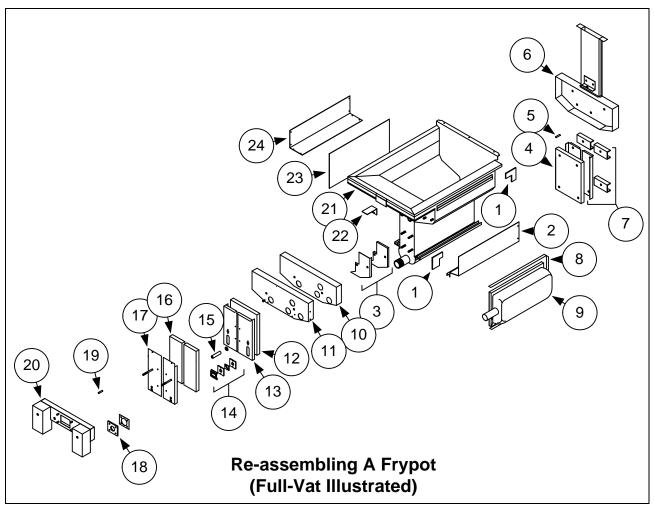
- 34. Install the upper burner rail blanket insulation (23). Position any excess insulation toward the top of the frypot. Avoid overhang past the bottom of the upper burner rail. Overhang in this area will make future burner replacement more difficult.

- 35. Cover the insulation with the insulation retainer (24), and secure with 1/4" self-tapping screws.
- 36. Reinstall probes, drain valves, AIF boards, actuators, high-limit thermostats, and other pipe fittings using Loctite® PST56765 sealant or equivalent on the threads.

- 11. Remove the upper burner rails (11). **NOTE:** For the following steps, refer to the frypot exploded view on page 1-16 for component identification.
- 12. Remove any residual insulation, sealant, and/or oil from the exterior of the frypot.
- 13. Place the "L" shaped pieces of the combustion chamber insulation (1) in the front and rear corners of both upper rail-retaining slots. (See page 1-16).
- 14. Using a mallet and short piece of wood, tap the corner tabs of the combustion chamber over the insulation to ensure a solid seal of the burner.
- 15. Install the upper burner rails (2) with the heat deflectors slanting toward the rear of the frypot. The rails will cover the "L" shaped pieces of combustion chamber insulation previously installed.

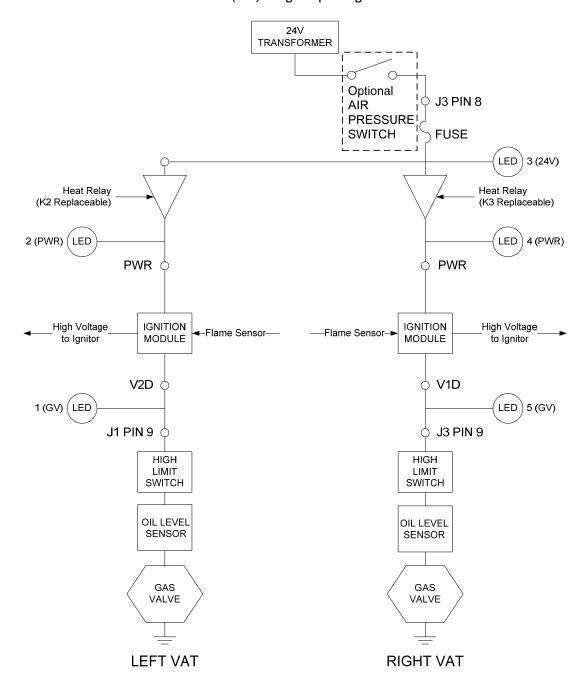
24 VOLT CIRCUIT
With Interface Board 106-6706 and
Two 807-5691 (DV) Single Spark Ignition Modules

24 VOLT CIRCUIT With Interface Board 106-6706 and Two 807-5691 (FV) Single Spark Ignition Modules 24V TRANSFORMER AĪR Optional PRESSURE **SWITCH** J3 PIN 8 **FUSE** LED 3 (24V) Heat Relay (K3 Replaceable) LED 4 (PWR) PWR (right side) IGNITION _ High Voltage to Right Ignitor Right Flame MODULE V1S 2 (PWR) (LED PWR (left side) _High Voltage to Left Ignitor IGNITION Left Flame MODULE Sensor V2S LED) 5 (GV) J3 PIN 9 HIGH LIMIT SWITCH OIL LEVEL SENSOR GAS VALVE

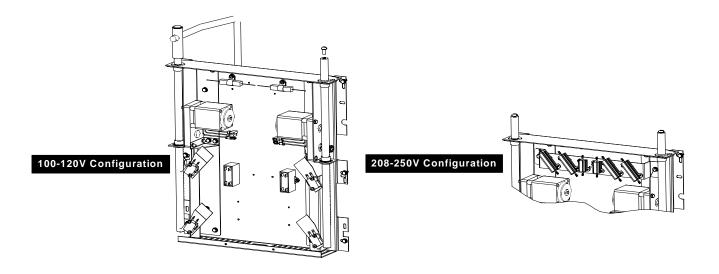
Problems with the basket lift can be grouped into three categories:

- Binding/jamming problems
- Motor and gear problems
- Electronic problems

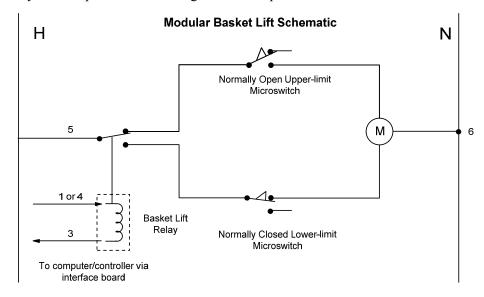
Within this category are problems associated with the relays, microswitches, capacitors, resistors, interface board, wiring, and controls. The most common problem in this category is a lift that continuously travels up and down. This is usually caused by a microswitch that is out of adjustment. Troubleshooting the electronics of a modular basket lift is simply a process of verifying current flow through the individual components up to and including the motor. Using a multimeter set to the 250 VAC range, check the connections on both sides of the component for the presence of the applied line voltage. The schematic below and the wiring diagram on page 1-70 and 1-71 can identify the components and wiring connection points.

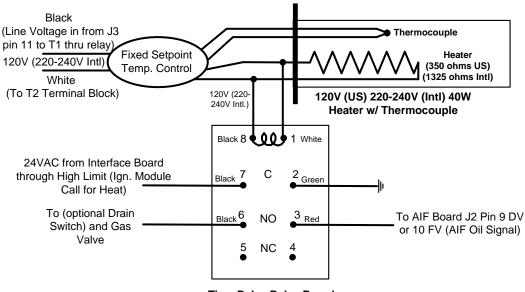
1.17.5.2 Oil Level Sensor Diagram

Time Delay Relay Board DPDT 7sec. Delay on Make

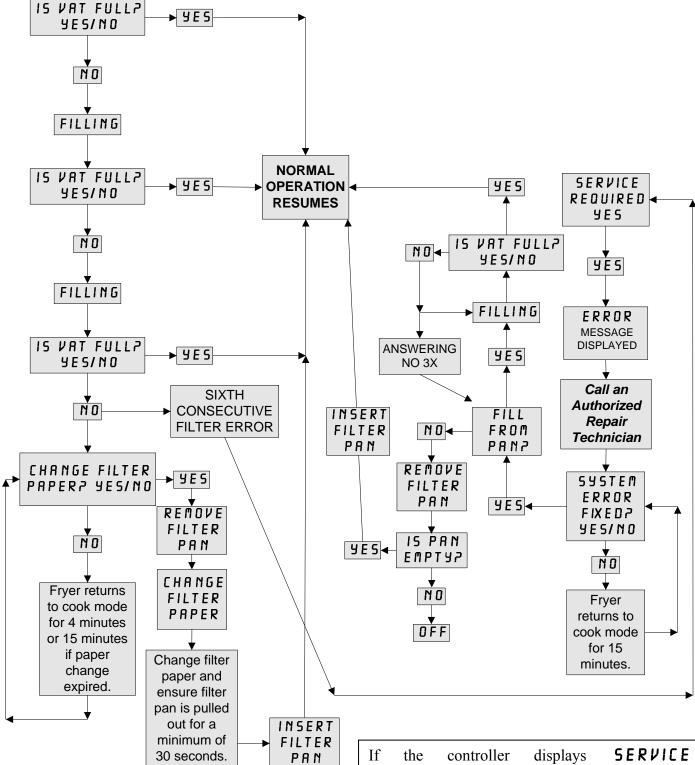
1.18.5 FilterQuick[™] Filter Error Flowchart

This chart follows the process of clearing a filtration issue. The prompt is displayed when any of the following occur:

- 1. a clogged filter paper,
- 2. a tripped or defective filter pump,
- 3. a leaky O-ring on the pick-up tube,
- 4. a failed drain valve/actuator, or
- 5. a failed return valve/actuator.

If the controller displays **SERVICE REQUIRED**, the fryer can be used in most cases by answering **NO** when the prompt for **SYSTEM ERROR FIXED? YES NO** is displayed. The message repeats every 15 minutes until the issue is repaired and error cleared by a answering **YES** when **SYSTEM ERROR FIXED? YES NO** is displayed.

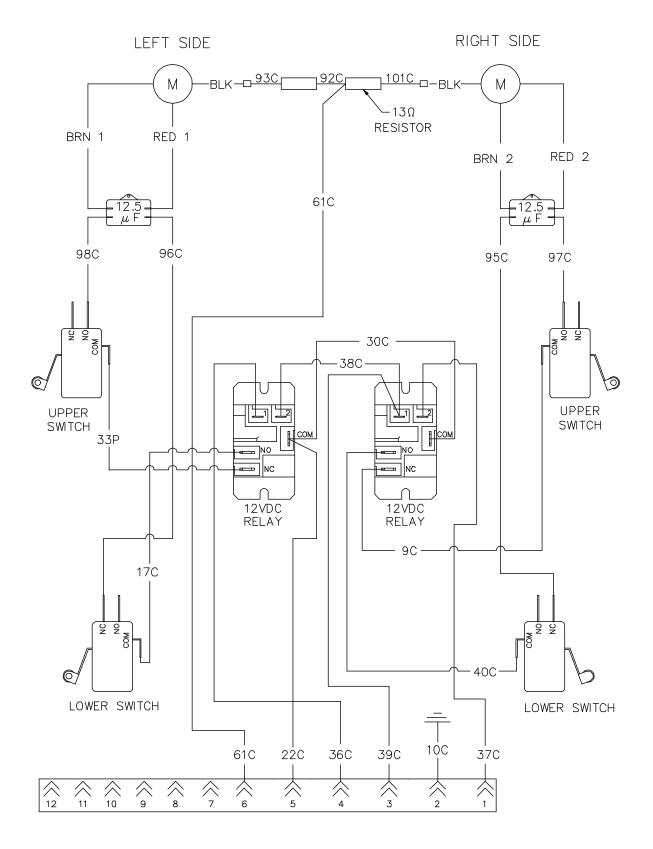
1.25 Modular Basket Lift Wiring Diagram 100-120V

REFERENCES TO LEFT & RIGHT ARE FROM THE REAR OF THE FRYER

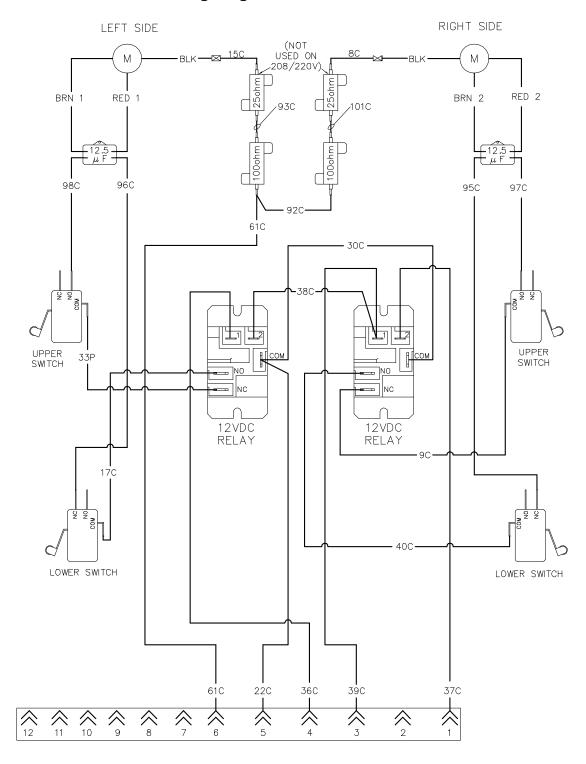
1.26 Modular Basket Lift Wiring Diagram 208-250V

REFERENCES TO LEFT & RIGHT ARE FROM THE REAR OF THE FRYER
