FilterQuick[™] FQGLA-T Gas Fryer

Service Manual

Part Number: FRY_SM_8197443 02/2018

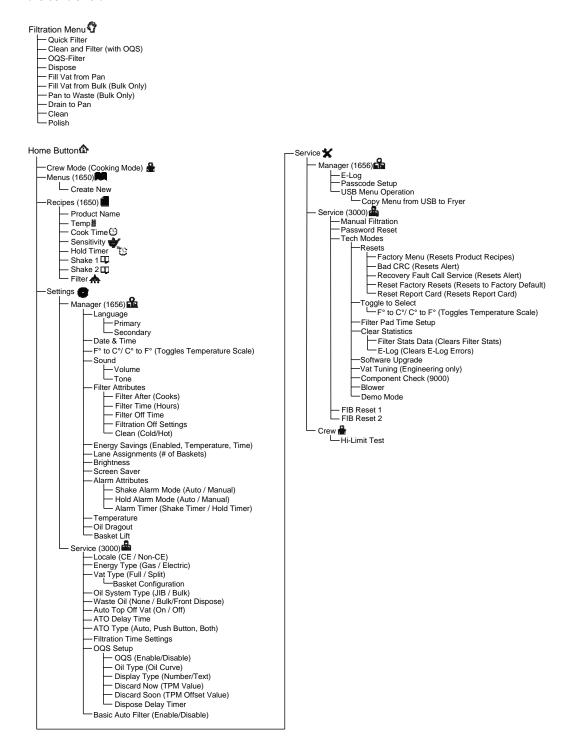
1.1.1 FQ4000 Menu Tree General Market/Burger King

Reflected below are the major programming sections in the FQ4000 and the order in which the headings will be found in the controller.

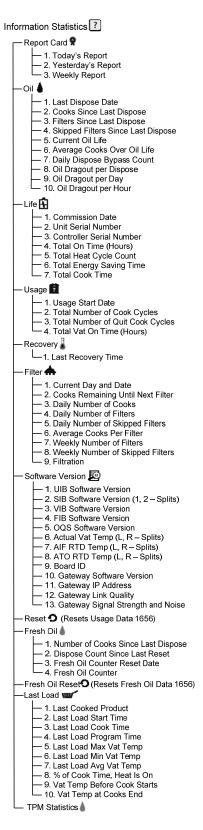
1.1.2 FQ4000 Information Statistics Menu Tree General Market/Burger King

Reflected below are the information statistics in the FQ4000 and the order in which the headings will be found in the controller

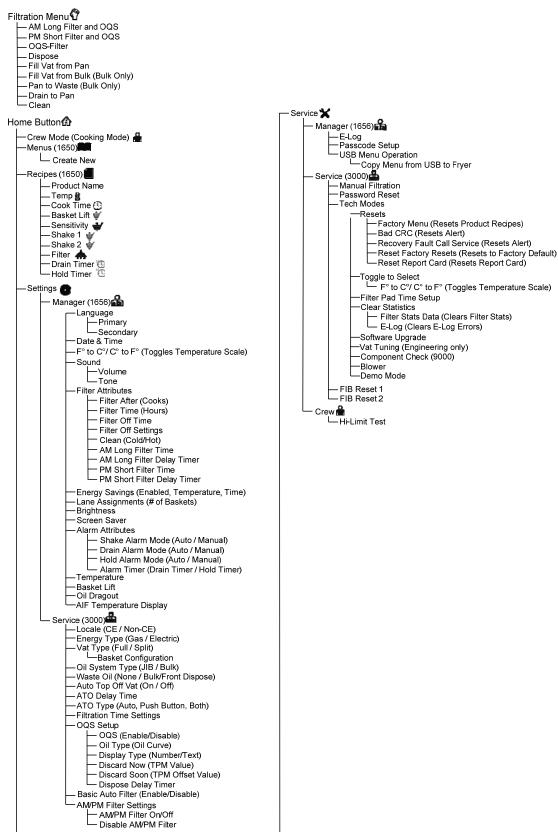
1.1.3 FQ4000 Menu Tree Taco Bell

Reflected below are the major programming sections in the FQ4000 and the order in which the headings will be found in the controller.

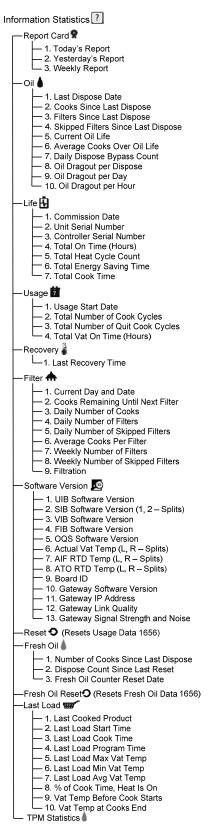
1.1.4 FQ4000 Information Statistics Menu Tree Taco Bell

Reflected below are the information statistics in the FQ4000 and the order in which the headings will be found in the controller

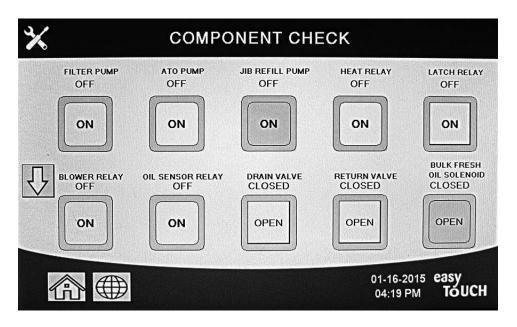
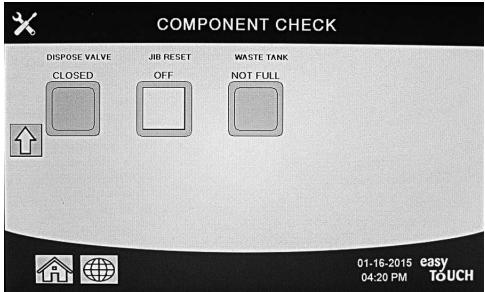
With the controller soft powered OFF, press the HOME button. Select Service, Service, Enter 9000, Select Tech Modes, scroll down and select Component Check.

The component name is above each button. The status of the component is below the function. Pressing the button will change the status of the function to what is stated on the button. If the button is shaded that function is not available unless that function is enabled (such as bulk). The JIB reset button and Waste Tank full only displays the status of the switch.

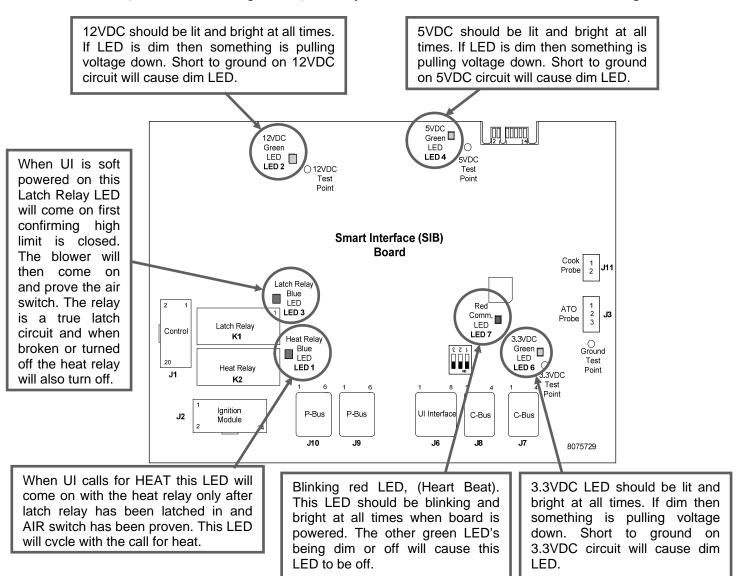
The SIB LEDs (labeled LED1 through LED7) are arrayed around the board to assist in troubleshooting.

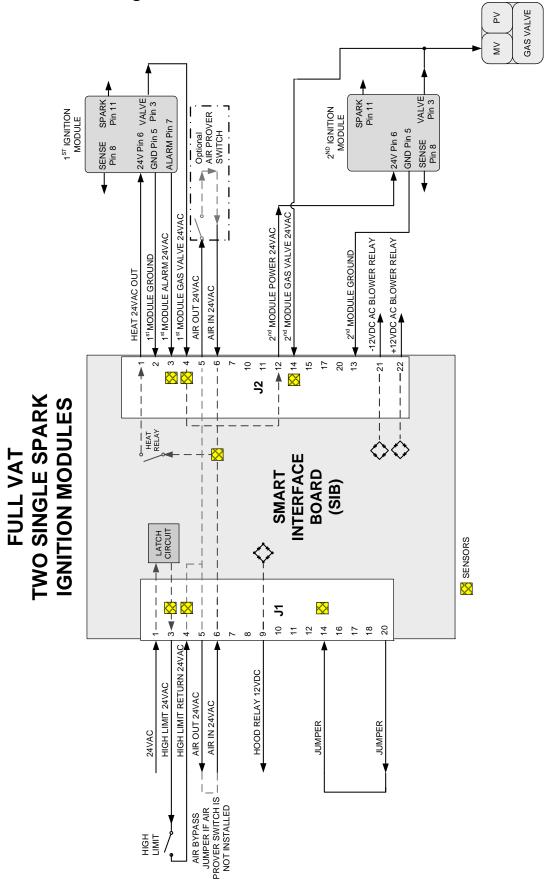
1.8.1 Full Vat flow through the SIB board

The charts on pages 1-8 and 1-9 illustrate current flow through the board, and the table at the top of page 1-10 identifies frequently used test points.

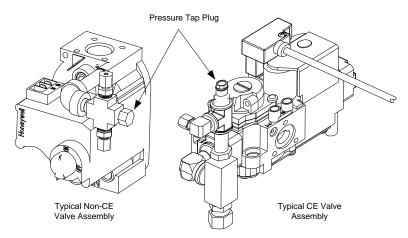
2. Remove the pressure tap plug from the gas valve assembly.

- 3. Insert the fitting for a gas pressure-measuring device into the pressure tap hole.
- 4. On non-CE fryers only, place the gas valve in the ON position
- 5. Place the fryer power switch in the ON position. When the burner has lit and burned steadily for at least one minute, compare the gas pressure reading to the pressure for the corresponding gas in the appropriate table on the following page. The tables on the following page list the burner manifold gas pressures for each of the gas types that can be used with this equipment.
- 6. To adjust the burner gas pressure, remove the cap from the gas valve regulator and adjust to the correct pressure.

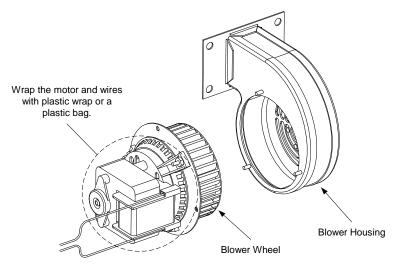
Figure 10

The air pressure switch on the combustion blower should read: Full Vat units-122pa (0.5 inches W.C.) and for Split Vat units-180pa (0.72 inches W.C.).

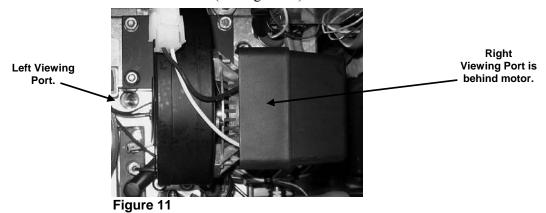
On the side of the blower housing opposite the motor is a shutter plate with a locking nut. Loosen the nut enough to allow the shutter to be moved, then adjust the position of the shutter to open or close the air intake opening until a bright orange-red glow is obtained, then close it slightly. Carefully hold the shutter in position and tighten the locking nut (see Figure 12).

On non-CE blowers loosen this nut and rotate shutter to open or close air intake.

On CE blowers loosen both wing nuts and slide the shutter to adjust the air intake.

The air/gas mixture is properly adjusted when the burner manifold pressure is in accordance with the applicable table on page 1-14 and the burners display a bright orange-red glow. If a blue flame is observed or if there are dark spots on a burner face, the air/gas mixture requires adjustment.

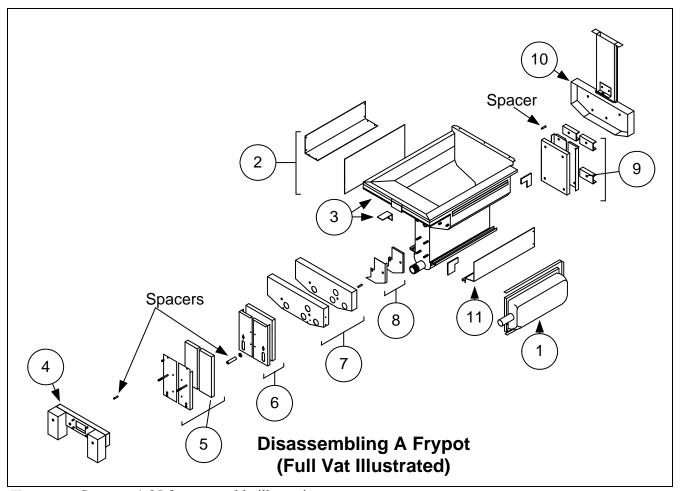
Figure 20 See page 1-25 for reassembly illustration.

- 9. Remove the rear lower combustion chamber retainers, back, and insulation (9). **NOTE:** Full-vat units have two-piece backs and four retainers. Dual-vat units have one-piece backs and two retainers.

- 10. Remove the flue assembly (10).

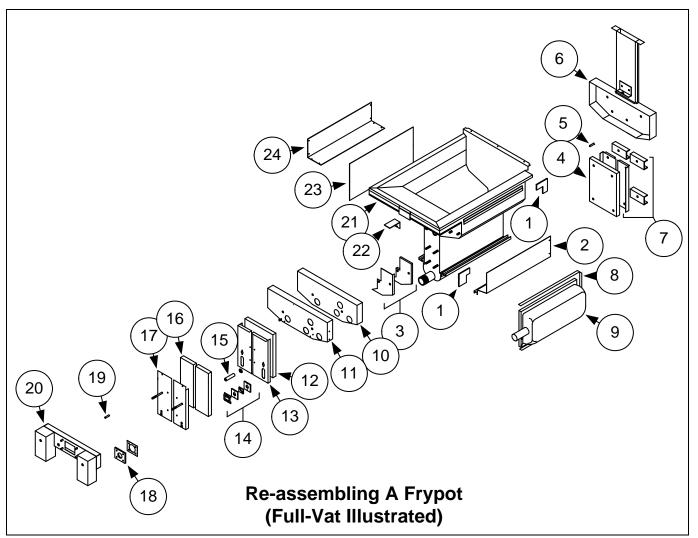
Figure 21

- 35. Cover the insulation with the insulation retainer (24), and secure with ½" self-tapping screws.
- 36. Reinstall probes, drain valves, VIB boards, actuators, high-limit thermostats, and other pipe fittings using Loctite® PST56765 sealant or equivalent on the threads.

- 11. Remove the upper burner rails (11). **NOTE:** For the following steps, refer to the frypot exploded view on page 1-25 for component identification.

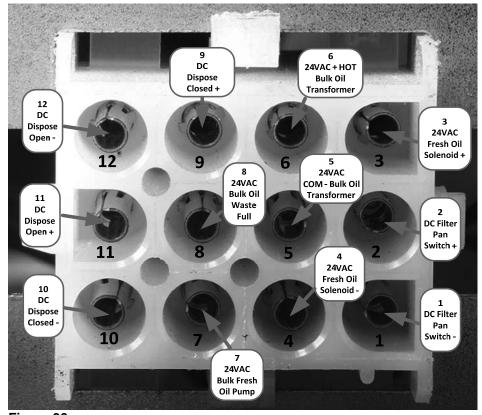
1.18.3.1 12 pin connector on rear of FIB (Filter Interface Board) box (C7)

Use these test pins to easily test these test points without removing the optional Solid Shortening heater.

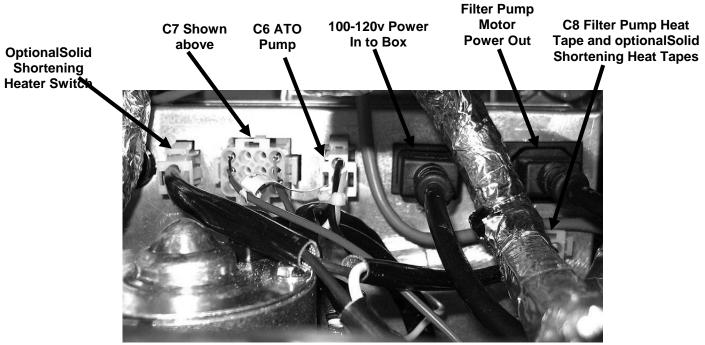
Figure 31

1.18.3.2 Connections on Figure 30 rear of FIB (Filter Interface Board) box

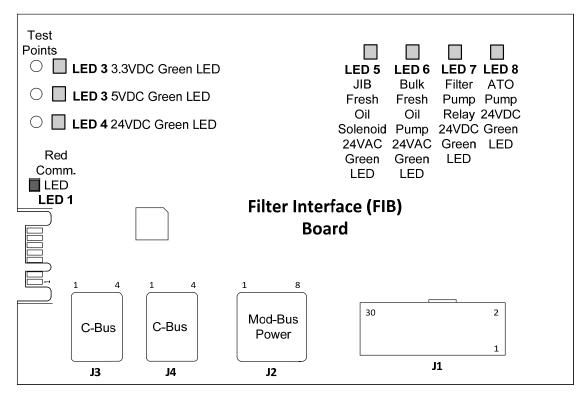
Figure 32a

Press the information (?) button; press the down arrow; press the SW version button to verify software version of the FIB. If the FIB software version is not visible, the FIB may not be connected properly.

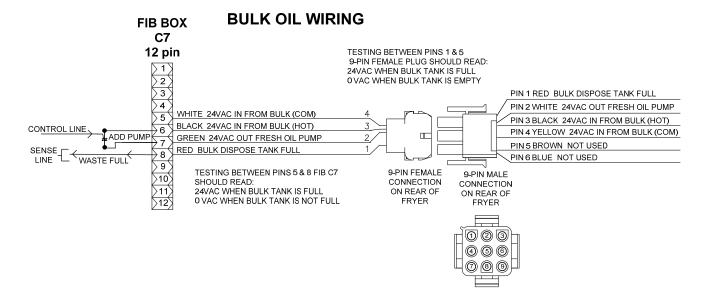
Figure 37

1.20.2 Bulk Oil Wiring Connection behind Fryer

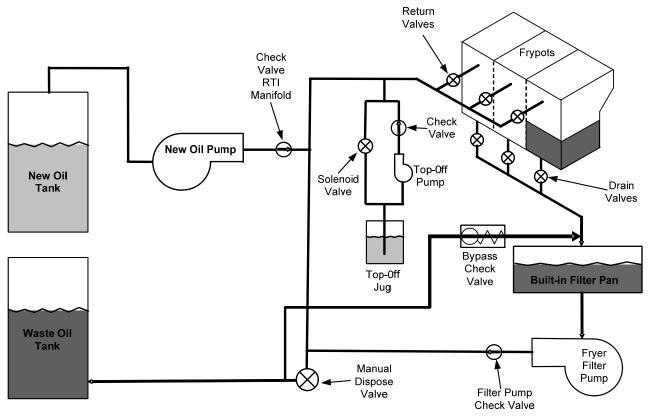
Figure 38

1.20.3 Frymaster FilterQuick-T Fryer and Bulk Oil System Plumbing Schematic

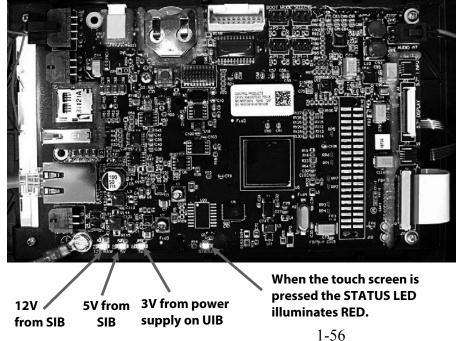
There are four (4) LED status lights on the rear of the controller which provide a quick method to verify power and touch screen functionality on the FQ4000 controller.

To verify that the FQ4000 has power and the touch screen is functional, remove the 2 screws attaching the controller to the bezel. Lower the controller to view the LED's on the read of the controller board. Verify that the three (3) green LED's are illuminated which indicate that 3V, 5V and 12V power is present on the controller. These should be illuminated at all times. Pressing anywhere on the front of the touch screen will illuminate the red LED STATUS (see photo below). The red LED will also illuminate during power up momentarily.
